CITY OF WINDCREST

A Capital Investment Program for the City of Windcrest

September 2011

RE: Capital Investment Program for the City of Windcrest, Texas

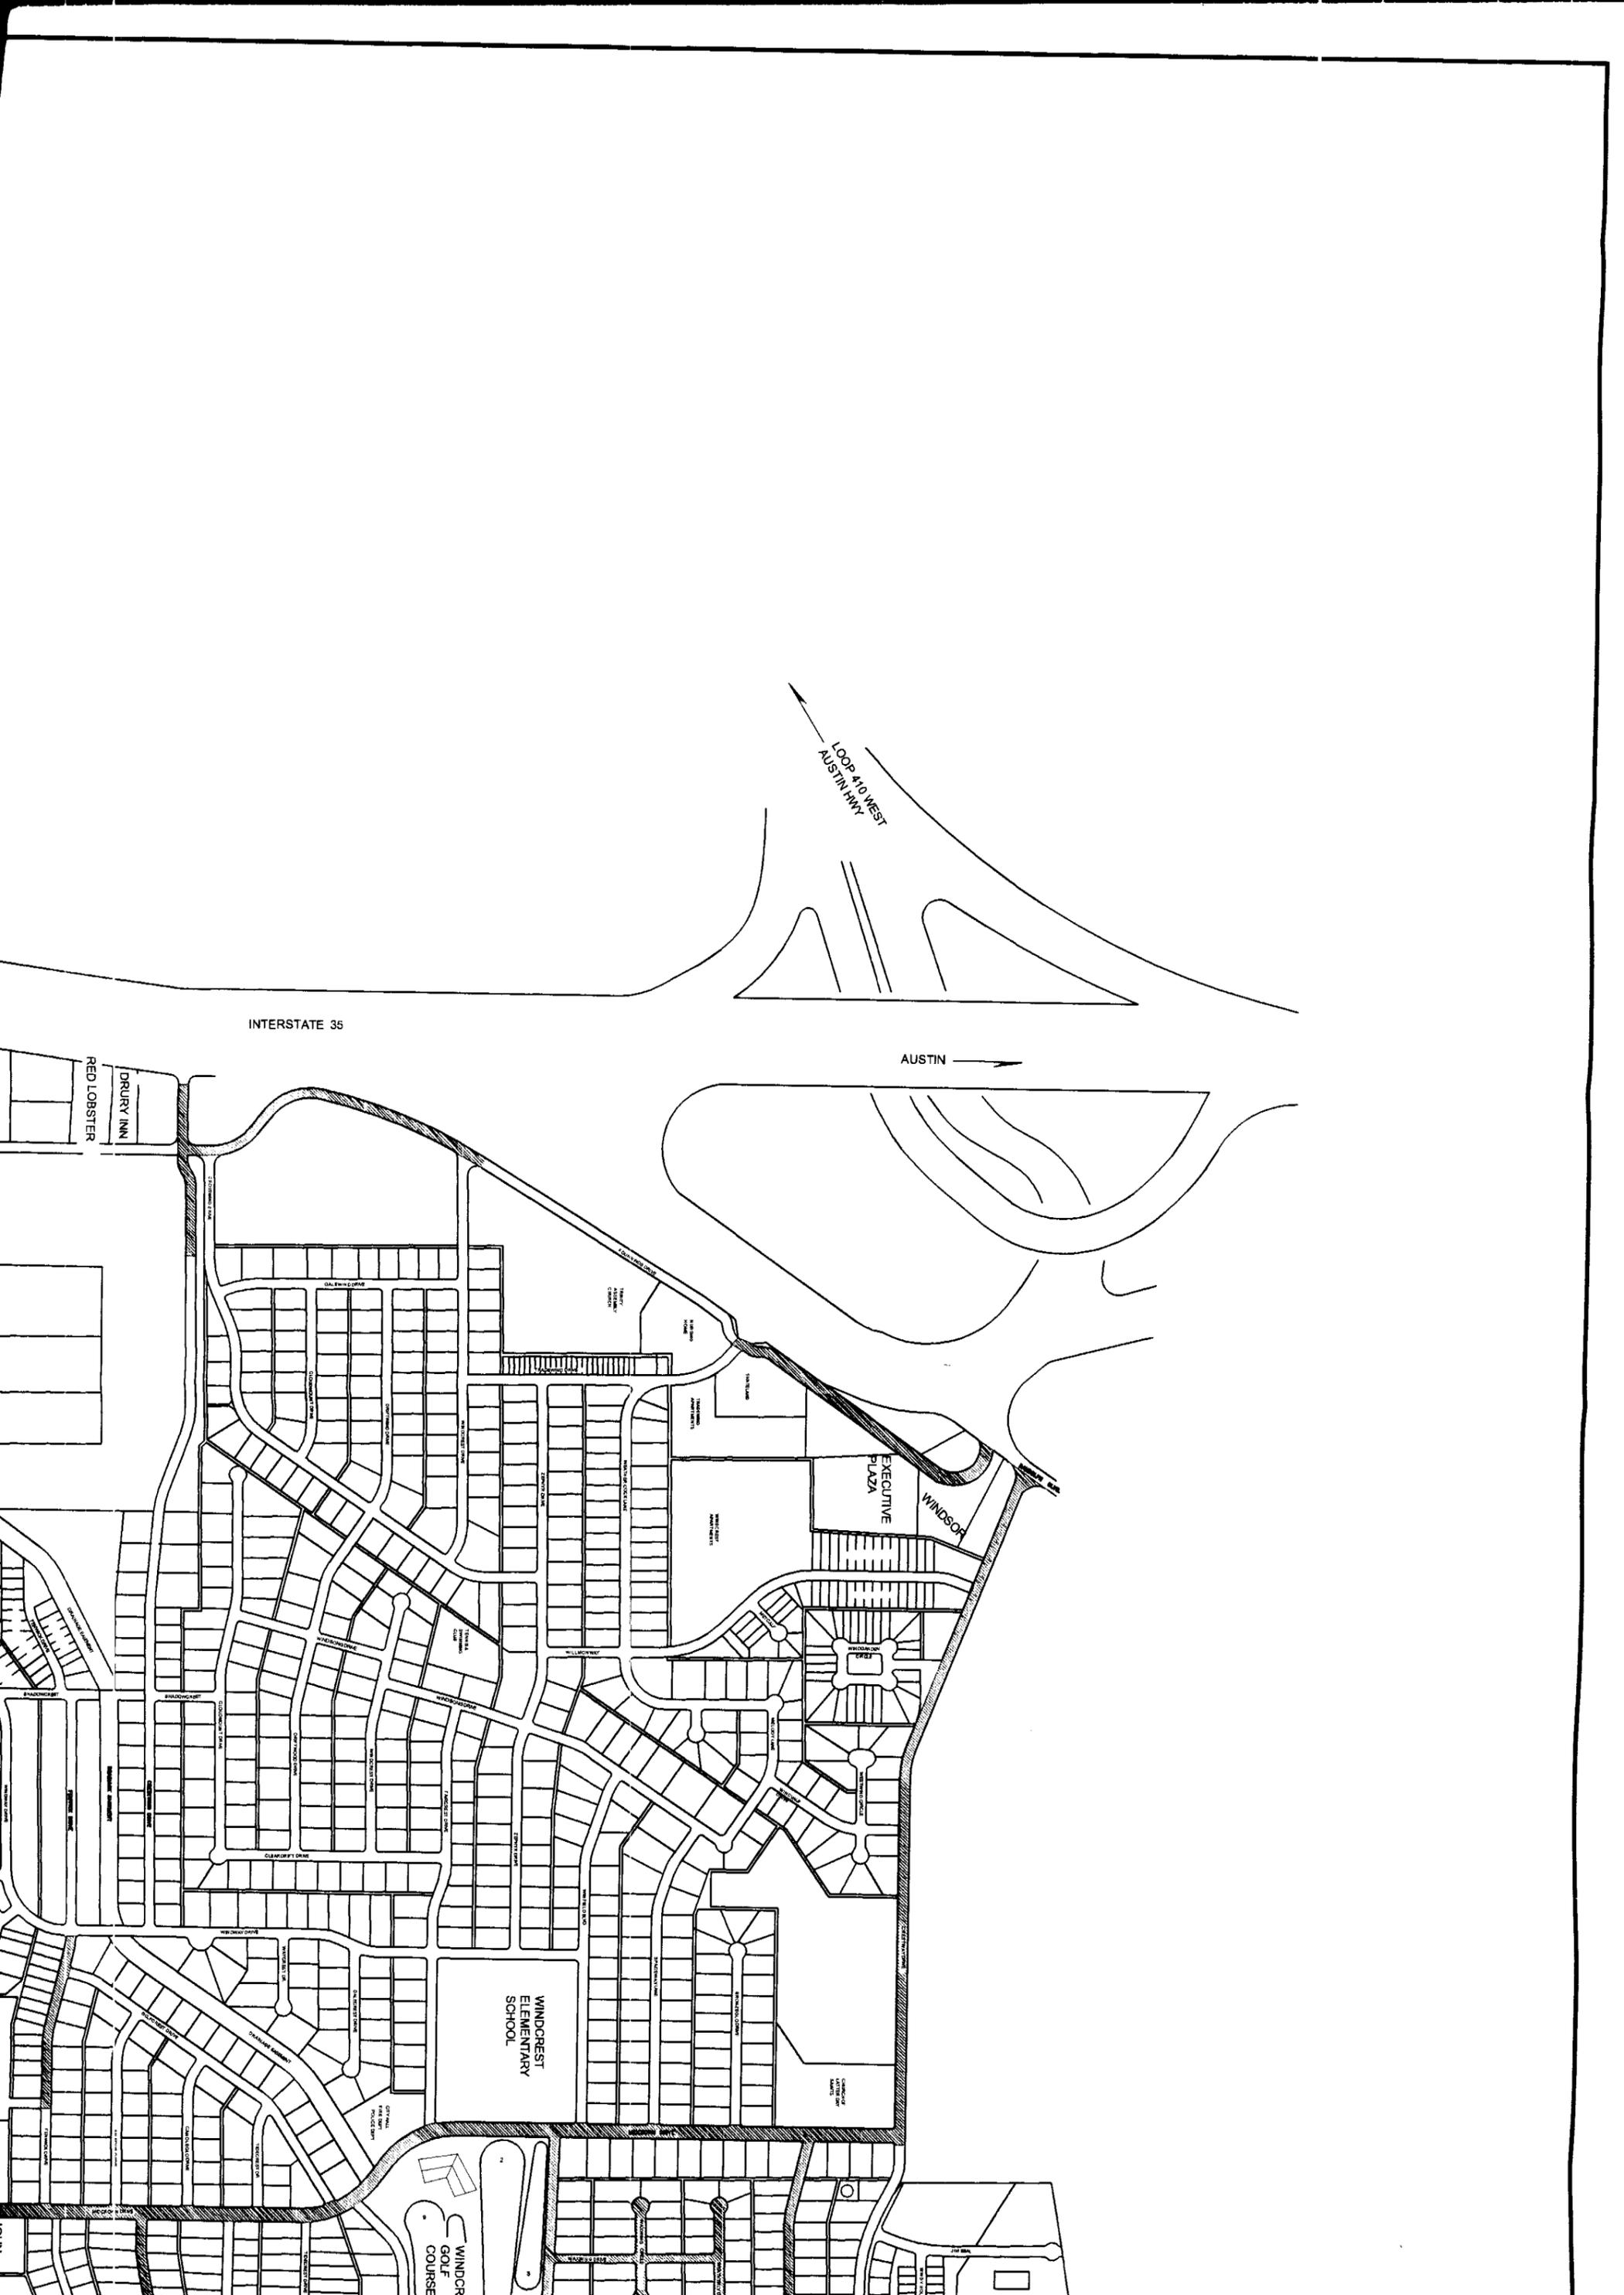
**APPENDIX C
PAVEMENT EVALUATION MAP**

Assessment Findings: No pavement has deteriorated to the extent that public safety or emergency services are impaired. Location, quantities, and severity of pavement distress are listed in the Pavement Deficiency Spreadsheet, which is included at Appendix A. The attached map (Appendix C) provides a color-coded overview of pavement sections of concern.

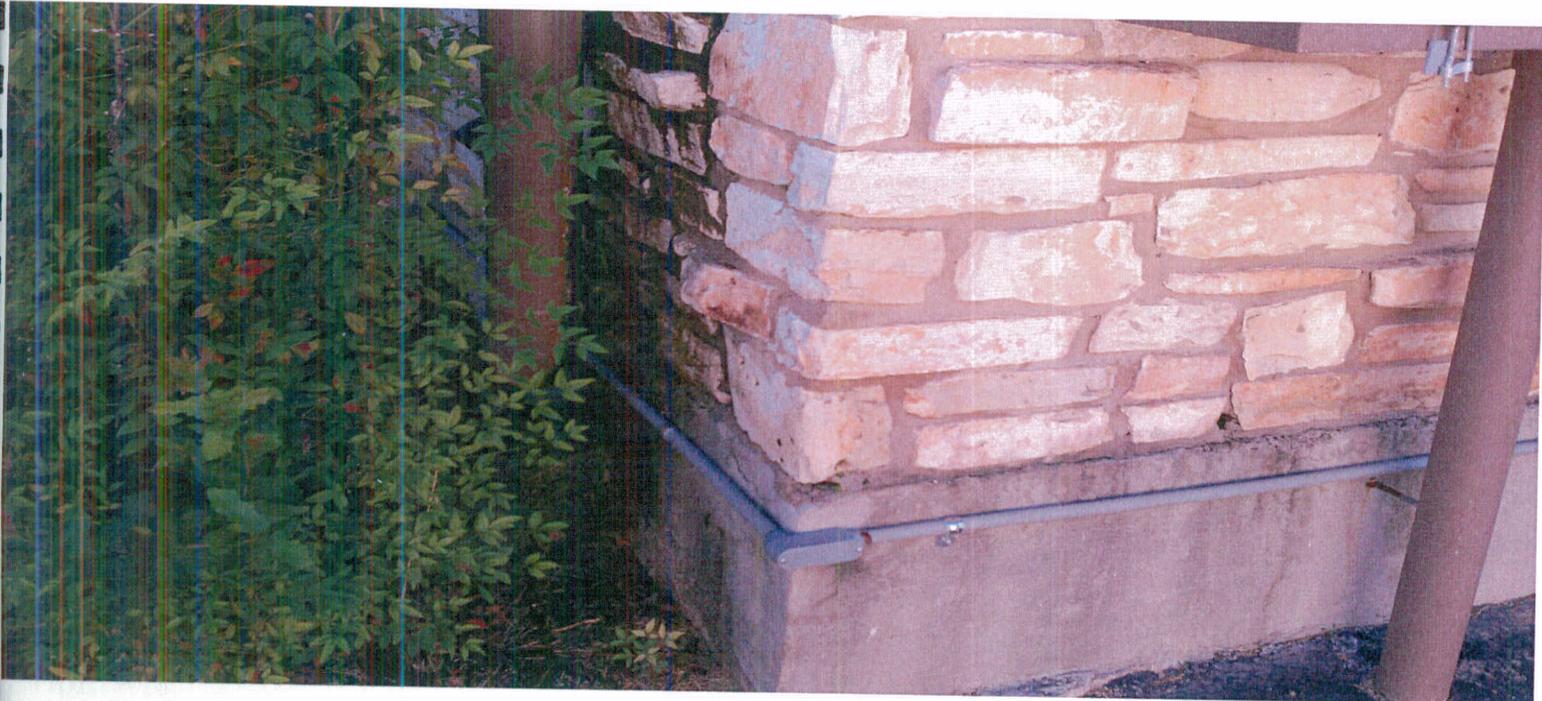
PHOTOGRAPH 1 – City Hall: downspouts require repair and/or replacement.

1. Repair/replace cracked concrete drive aprons and install joint material at joints.
2. Repair tripping hazards at sidewalk left of entrance.
3. Replace downspouts with heavier material and drain away from building (especially at EMS/Fire Department rear area).

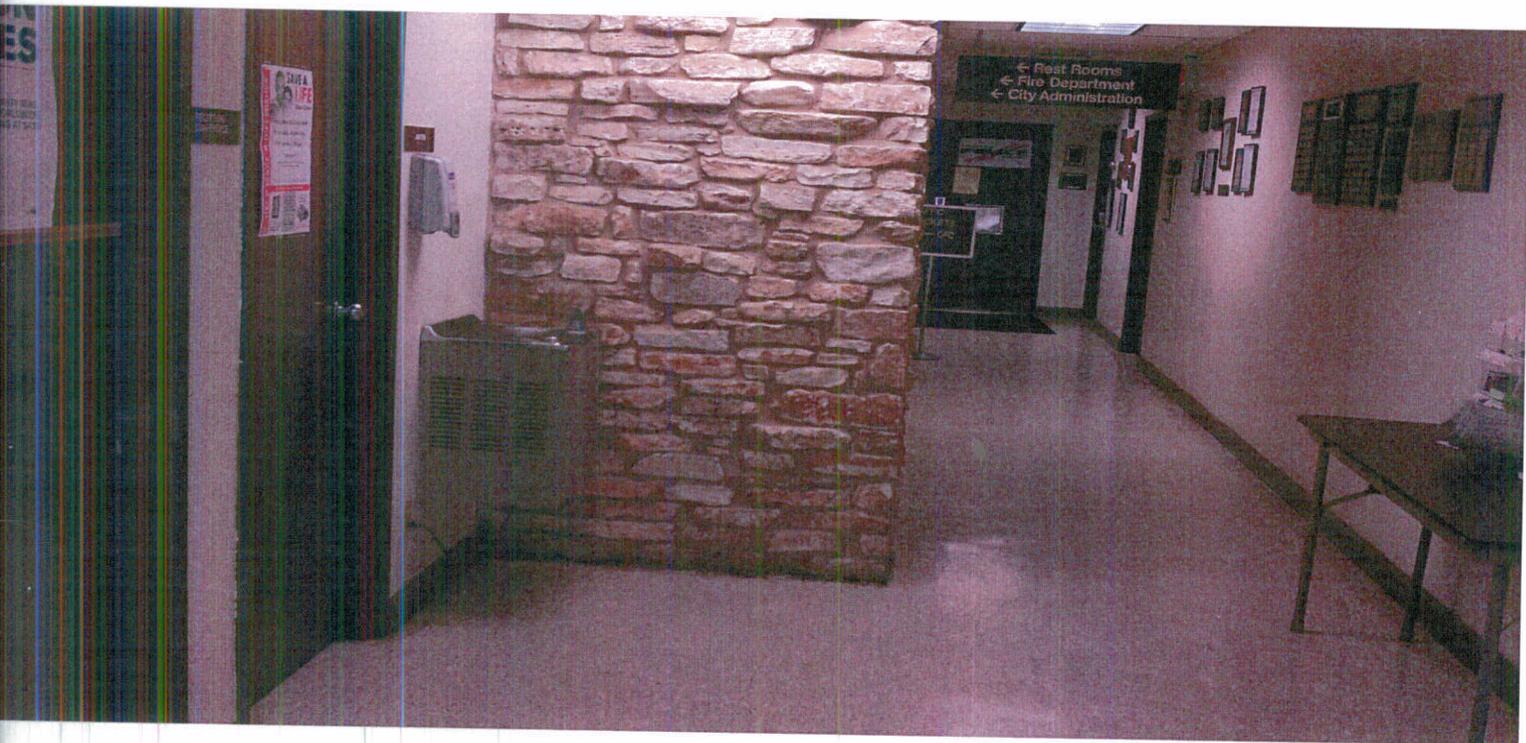
PHOTOGRAPH 2 – City Hall: interiors are dated and lack accessibility features.

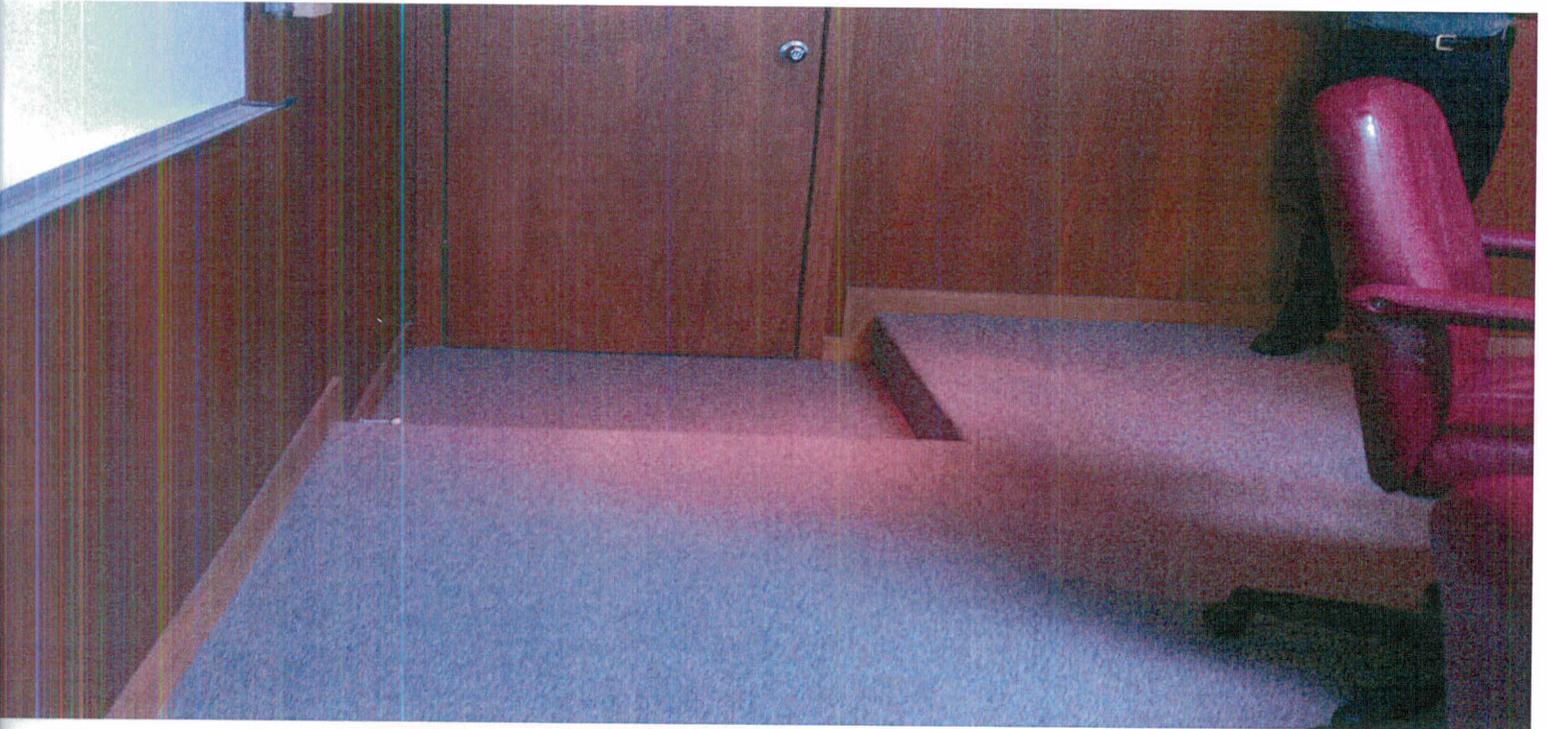
PHOTOGRAPH 3 – City Hall Council Chambers: tripping hazards and accessibility challenges.

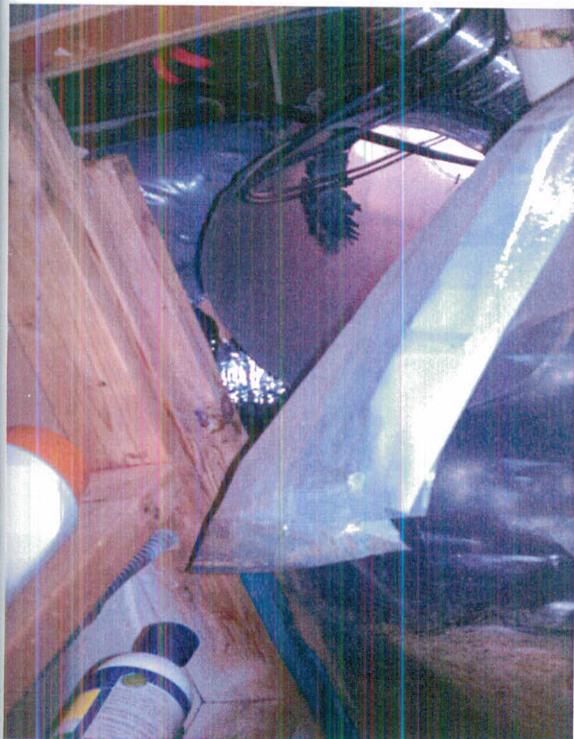
PHOTOGRAPH 4 – City Hall: Seal openings to the roof at water heater closet.

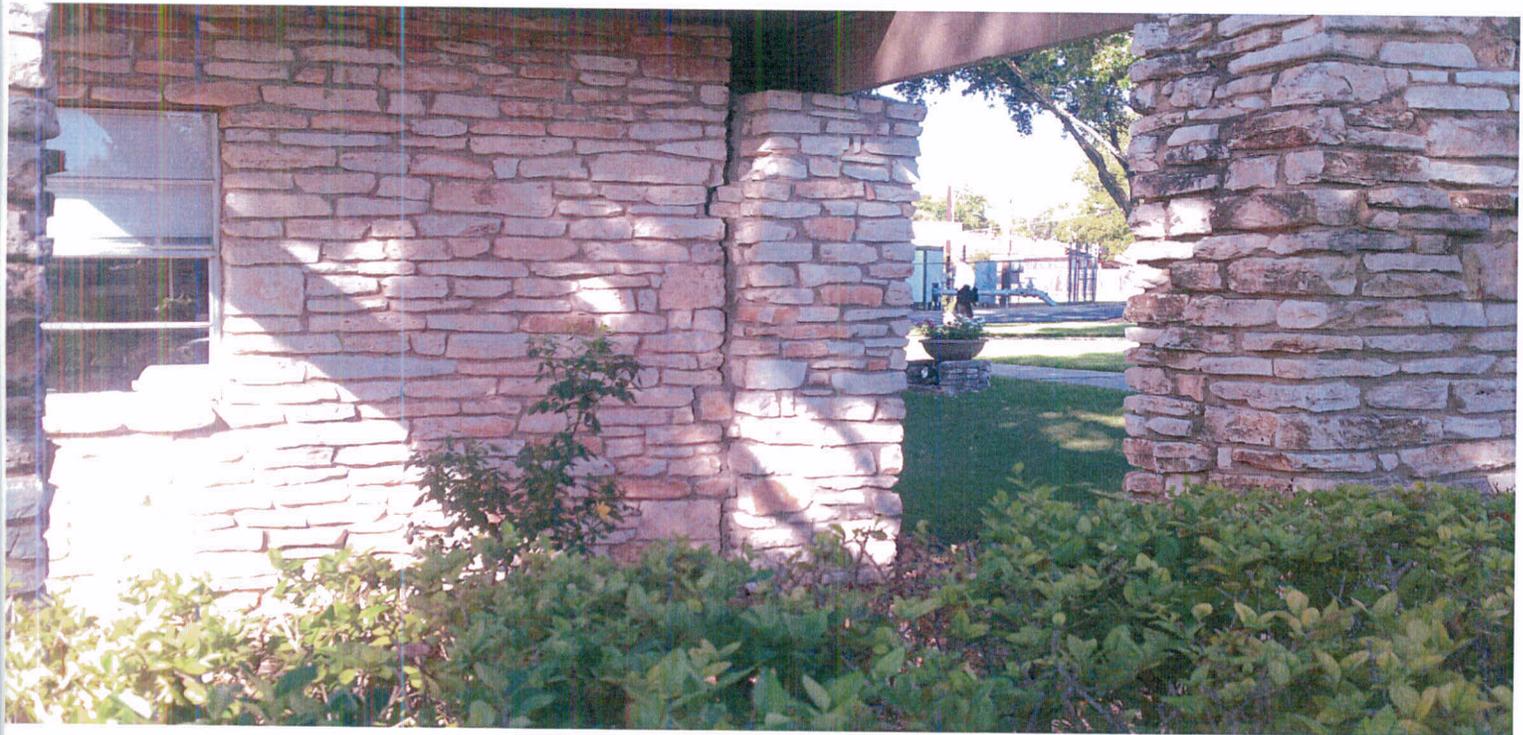
PHOTOGRAPH 5 – City Hall: tilted and detached pilaster requires foundation stabilization.

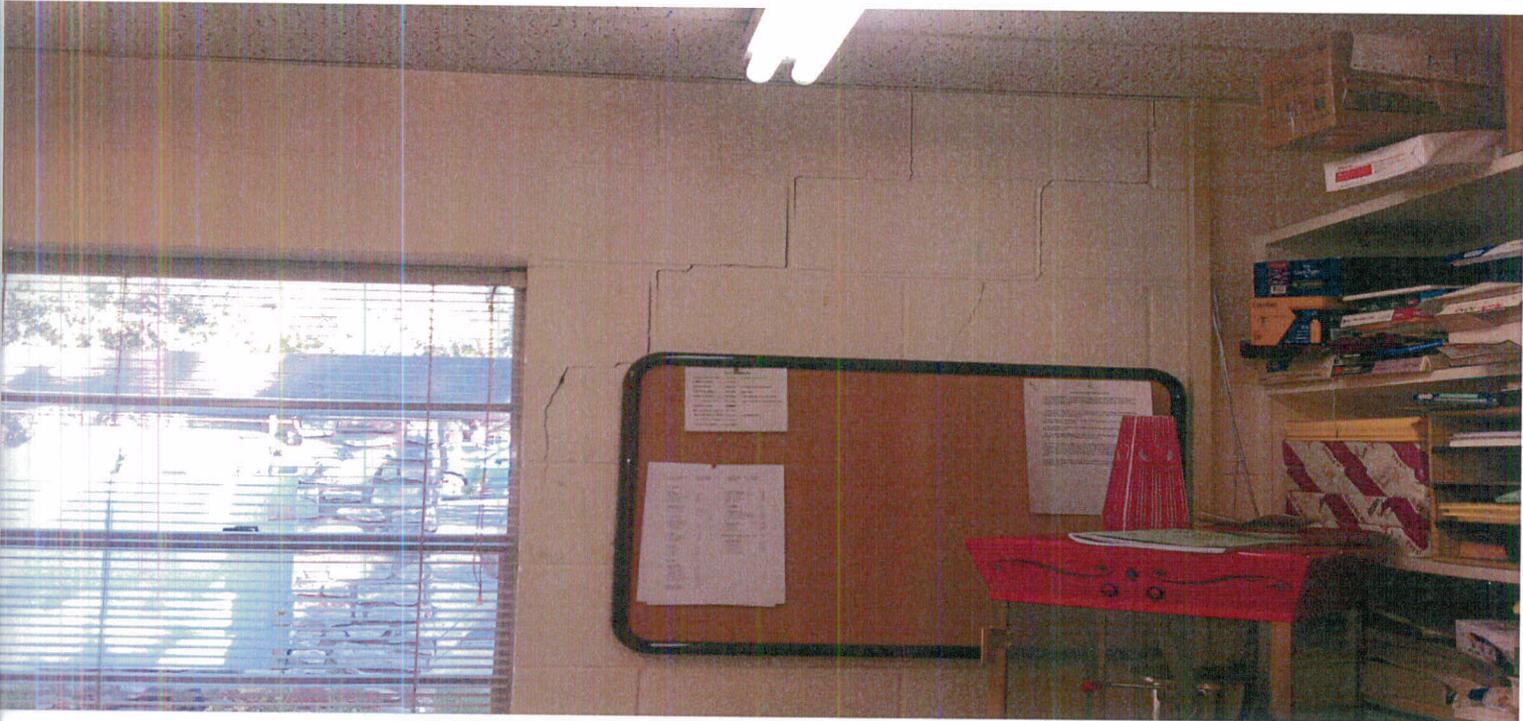
PHOTOGRAPH 6 – City Hall: Interior wall at copy room requires repair.

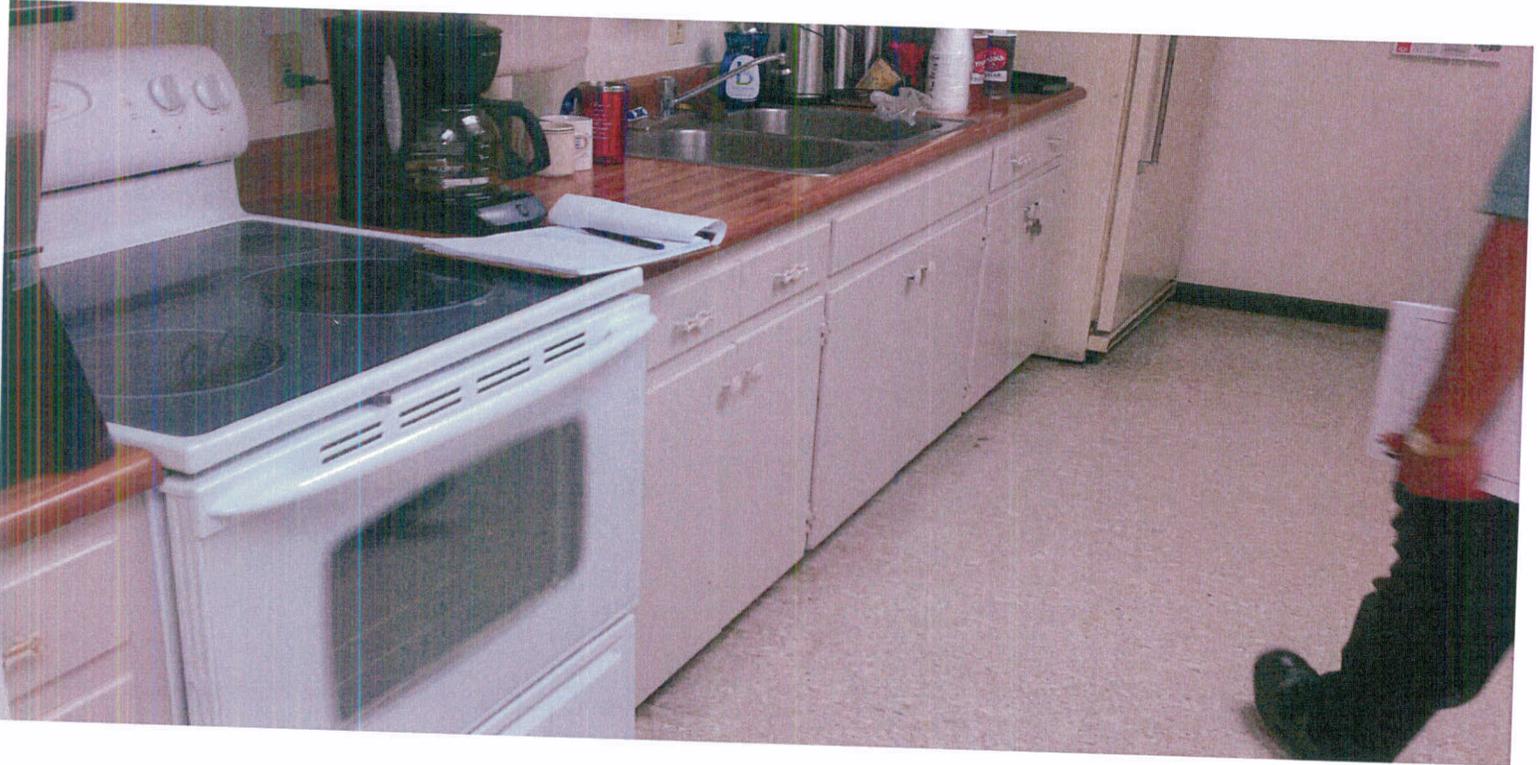
PHOTOGRAPH 7 – City Hall: Kitchen/break area requires updating.

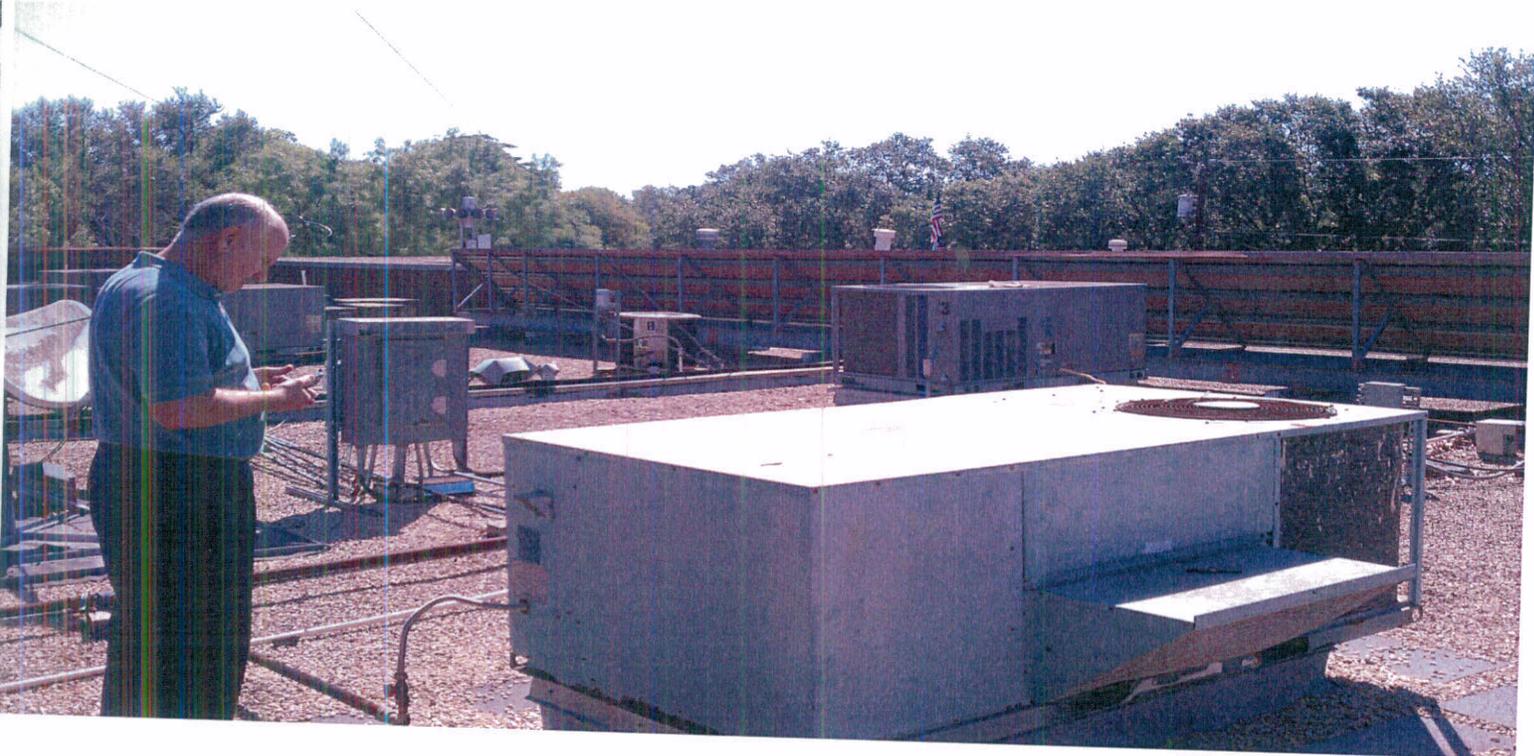
The original building was constructed in 1972 and several building additions have been added since. As a result, there are 16 roof top mounted air conditioning units, the interior layout is inefficient and the appearance is dated.

PHOTOGRAPH 8 – City Hall: Roof-mounted air conditioning units are different ages and energy efficiencies.

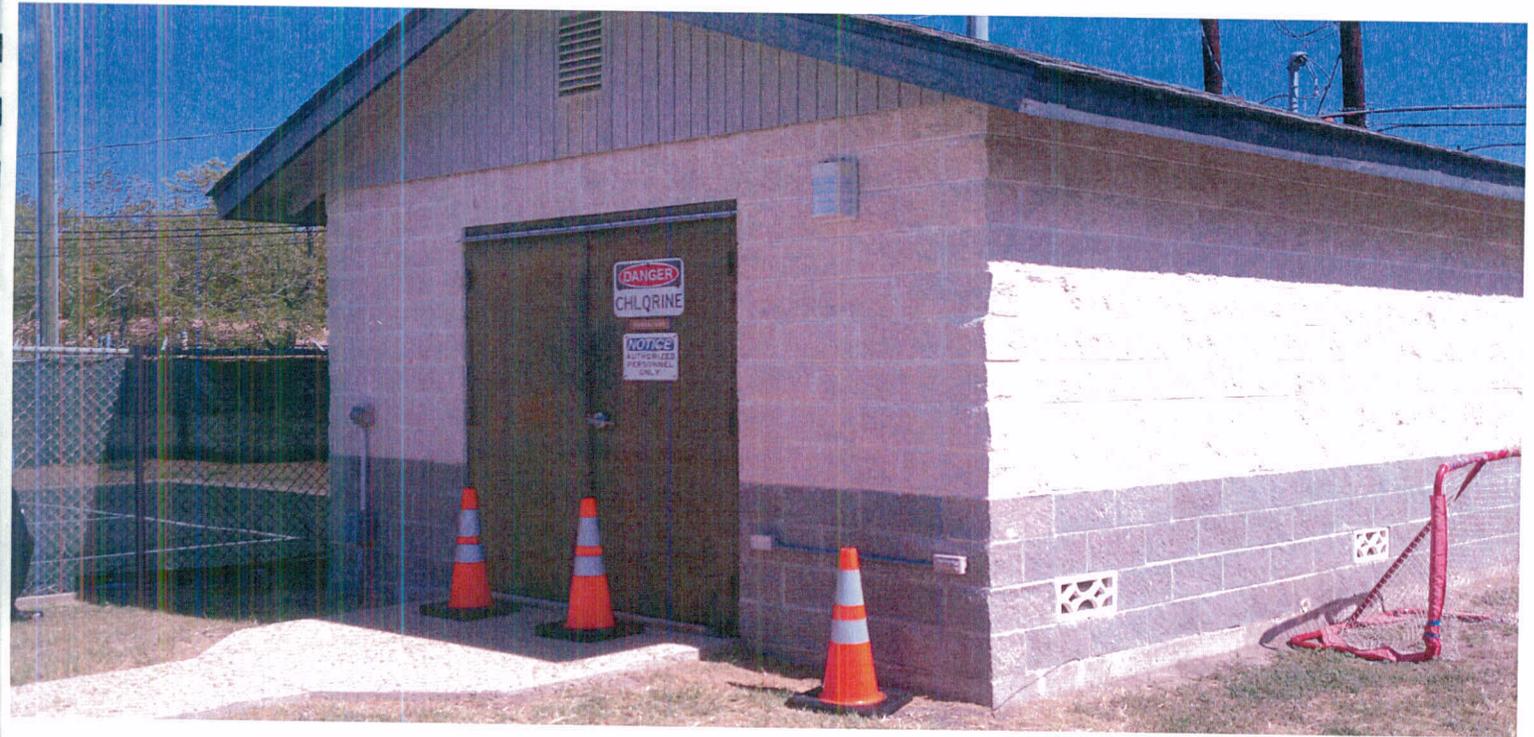
Pump and Filter house: The interior of the pump house was not available for assessment. Inspect chlorine dosing equipment for leaks and inspect vents and ventilation equipment for poor ventilation rates. Corrosion is evident on metal doors, vents and fencing, probably due to excessive venting of Chlorine. Some intake vents may be blocked as very little ventilation suction was evident. Replace or repair corroded pump house louvers, exterior metal door, frame and galvanized cage area at the side of the pump house. The estimated cost for repairs is \$2,000.00.

PHOTOGRAPH 11 – Swimming Pool Pump/Filter House: Evaluate mechanical ventilation, replace and/or paint metal items
